EPRI NP-6931  
Project 2558-8  
Final Report  
September 1990

# The Cleanup of Three Mile Island Unit 2

## A Technical History: 1979 to 1990

Prepared by Grove  
Engineering, Inc.  
Rockville, Maryland

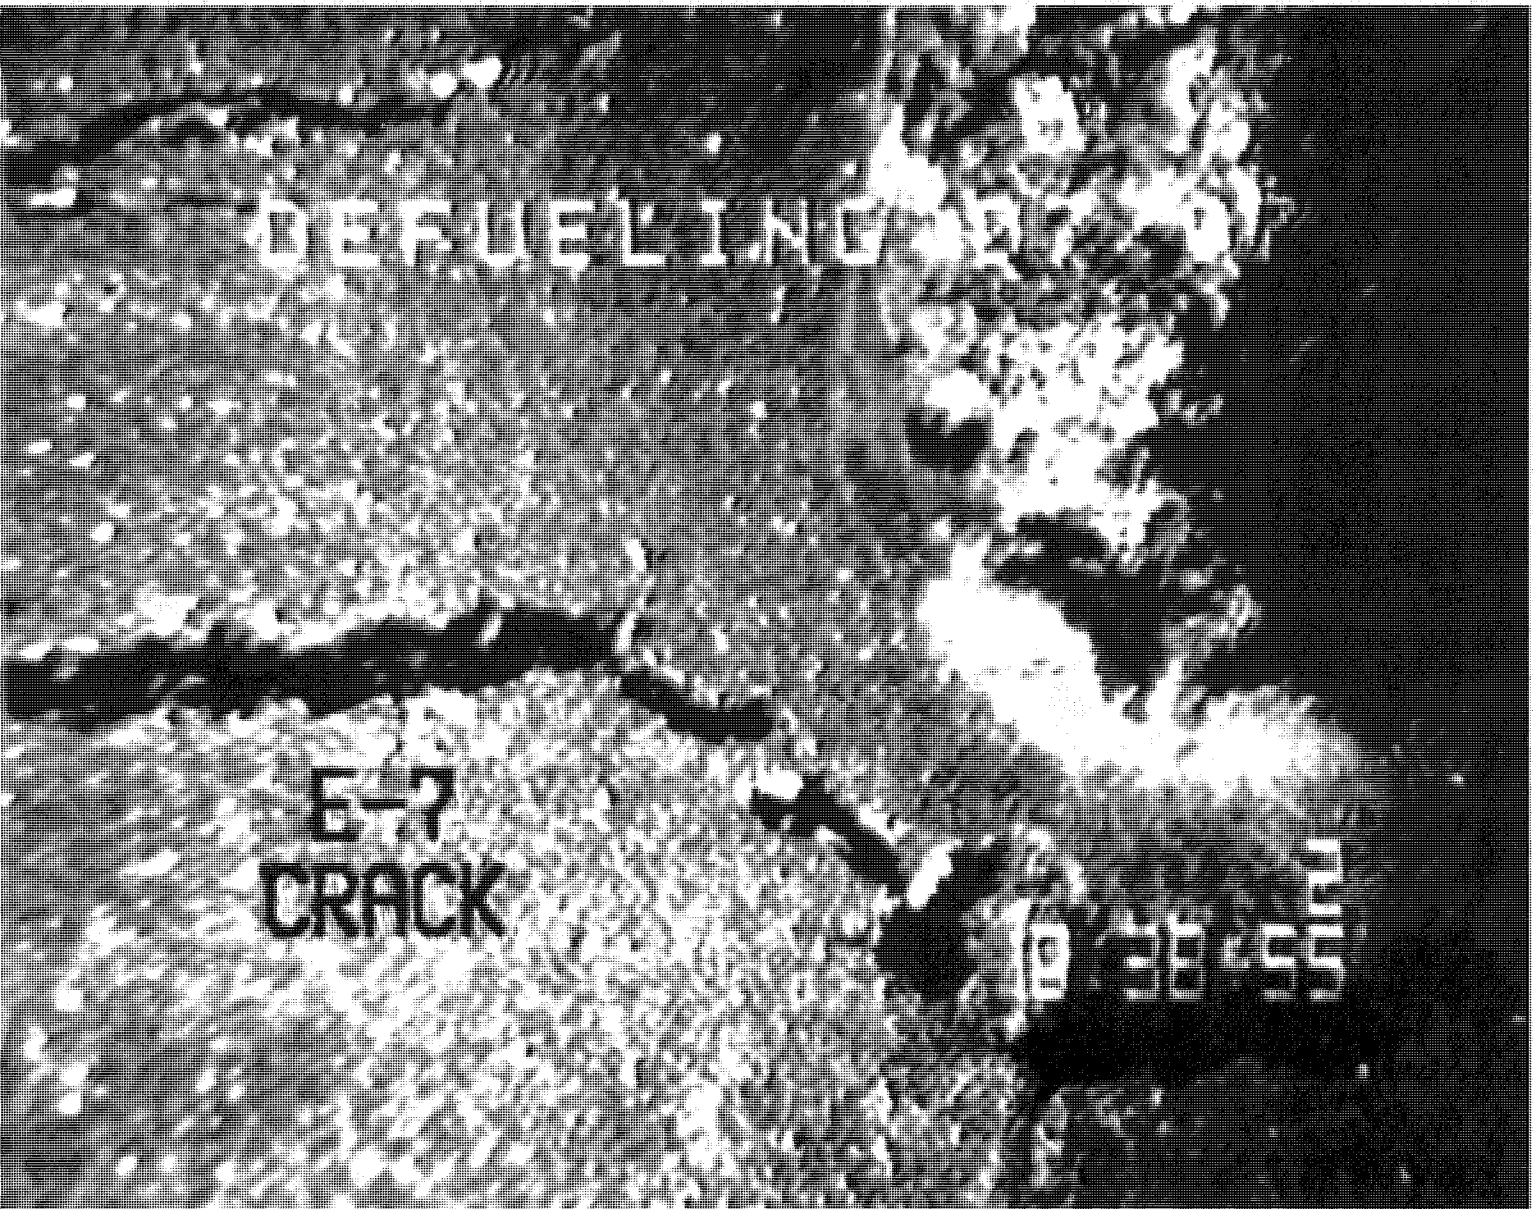
Photo 5-4. A Crack in the Lining of the Lower Head of Reactor Vessel Near Incore Nozzle E-7

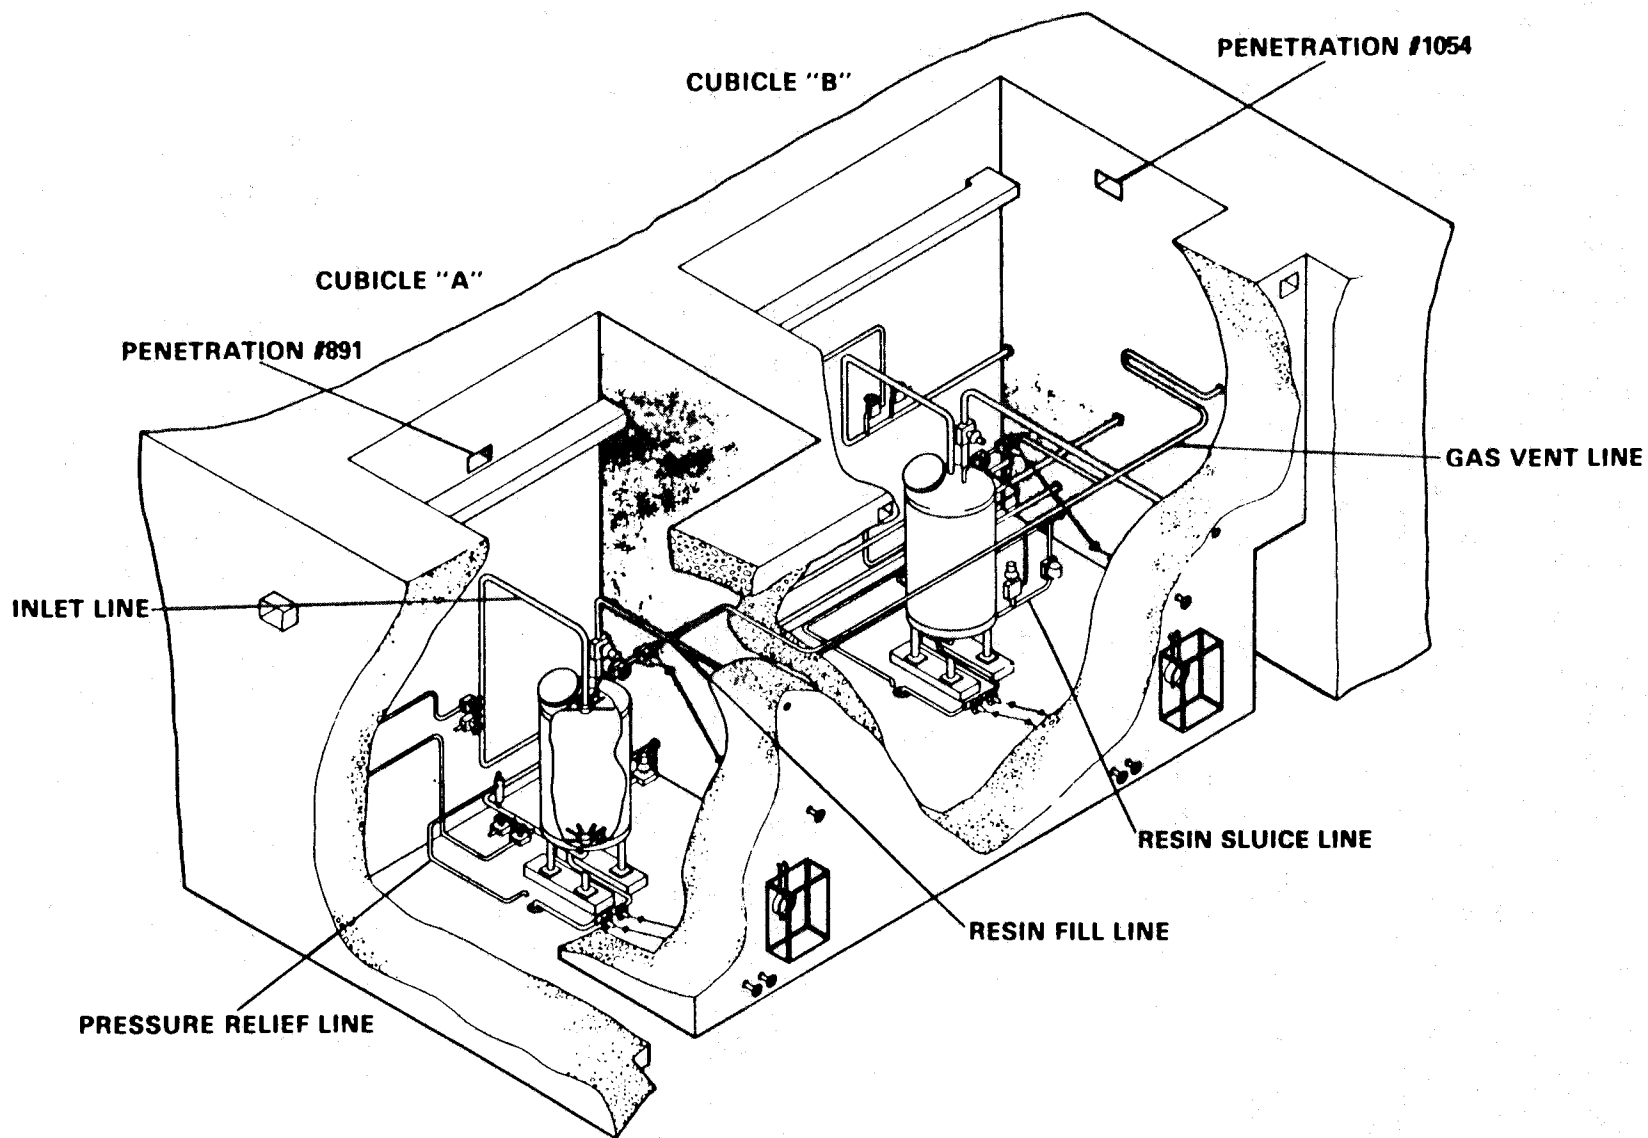
Figure 7-2. Makeup & Purification Demineralizer Cubicles

The cleanup of the two makeup and purification (MUP) demineralizer vessels was unique because it was a low-profile, challenging project that proceeded with little fanfare over several years. The radioactivity contained in the vessels was substantial, but not in a location that interfered with cleanup and defueling operations.

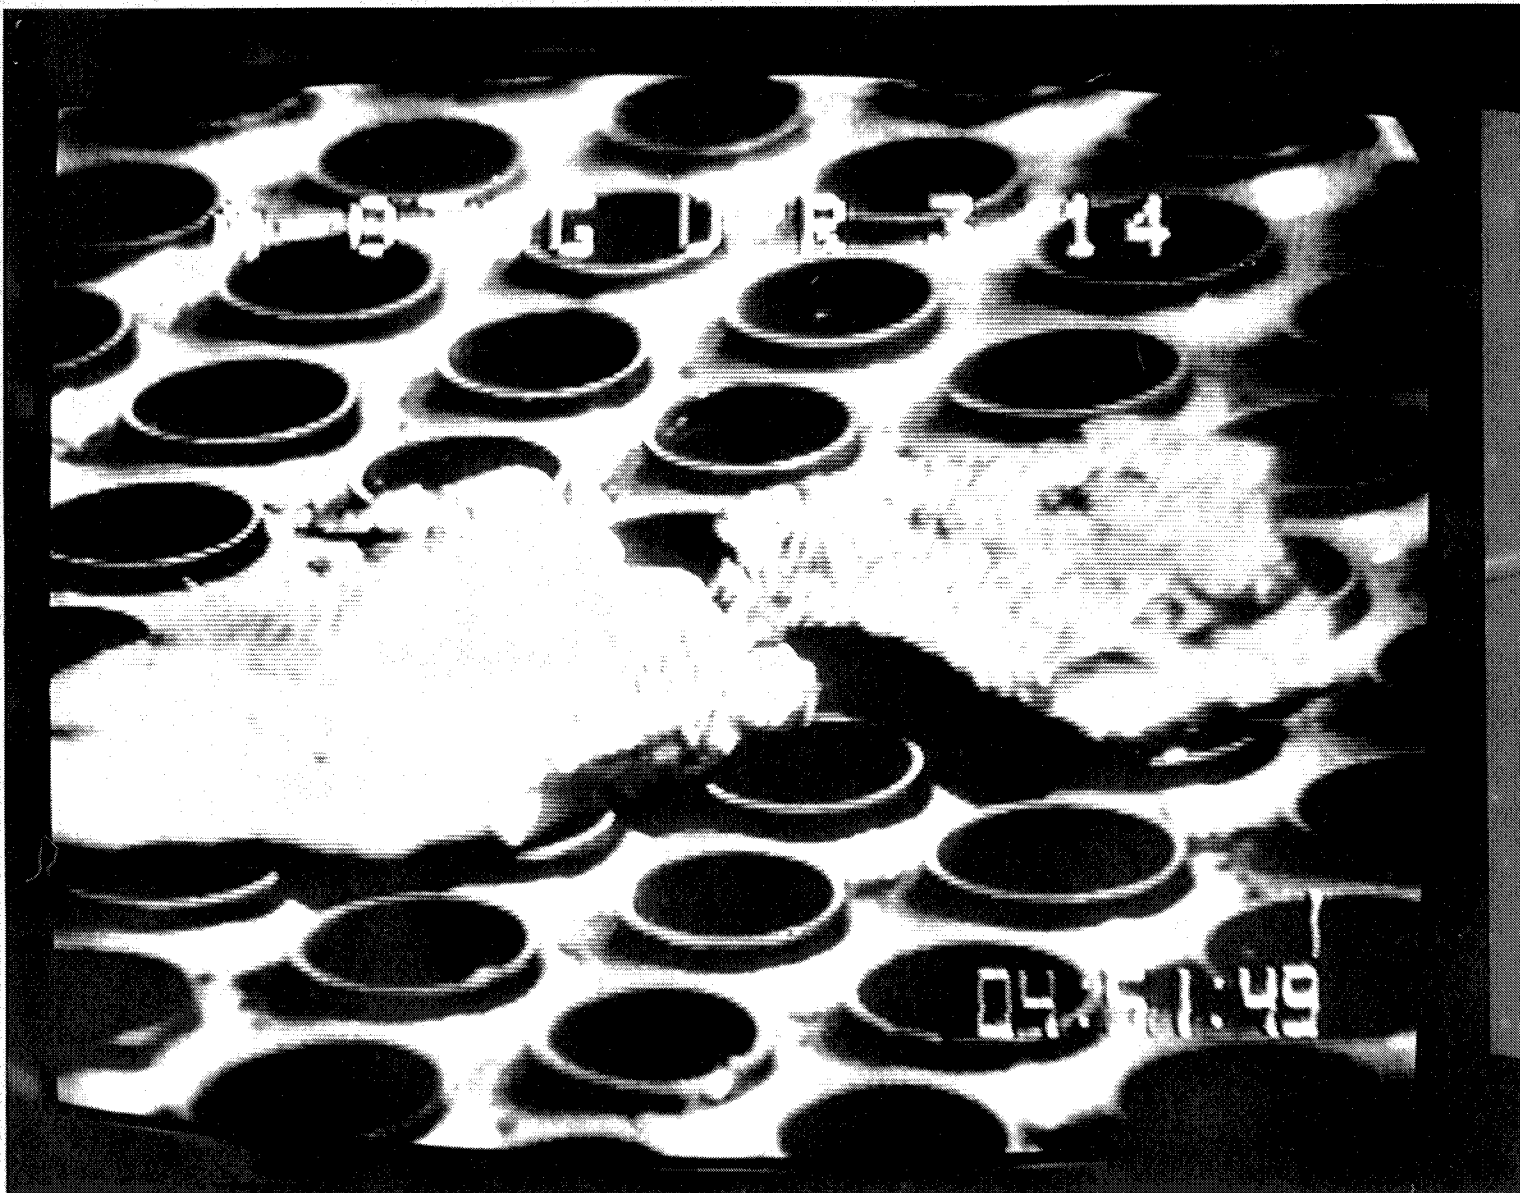
Photo 8-12. Debris on Tube Sheet of a Once-Through Steam Generator
